Bassett Creek Nature Area

Location: 2130 Zane Avenue

Basset Creek Nature Area - Land Cover
Golden Valley Natural Resources Management Plan

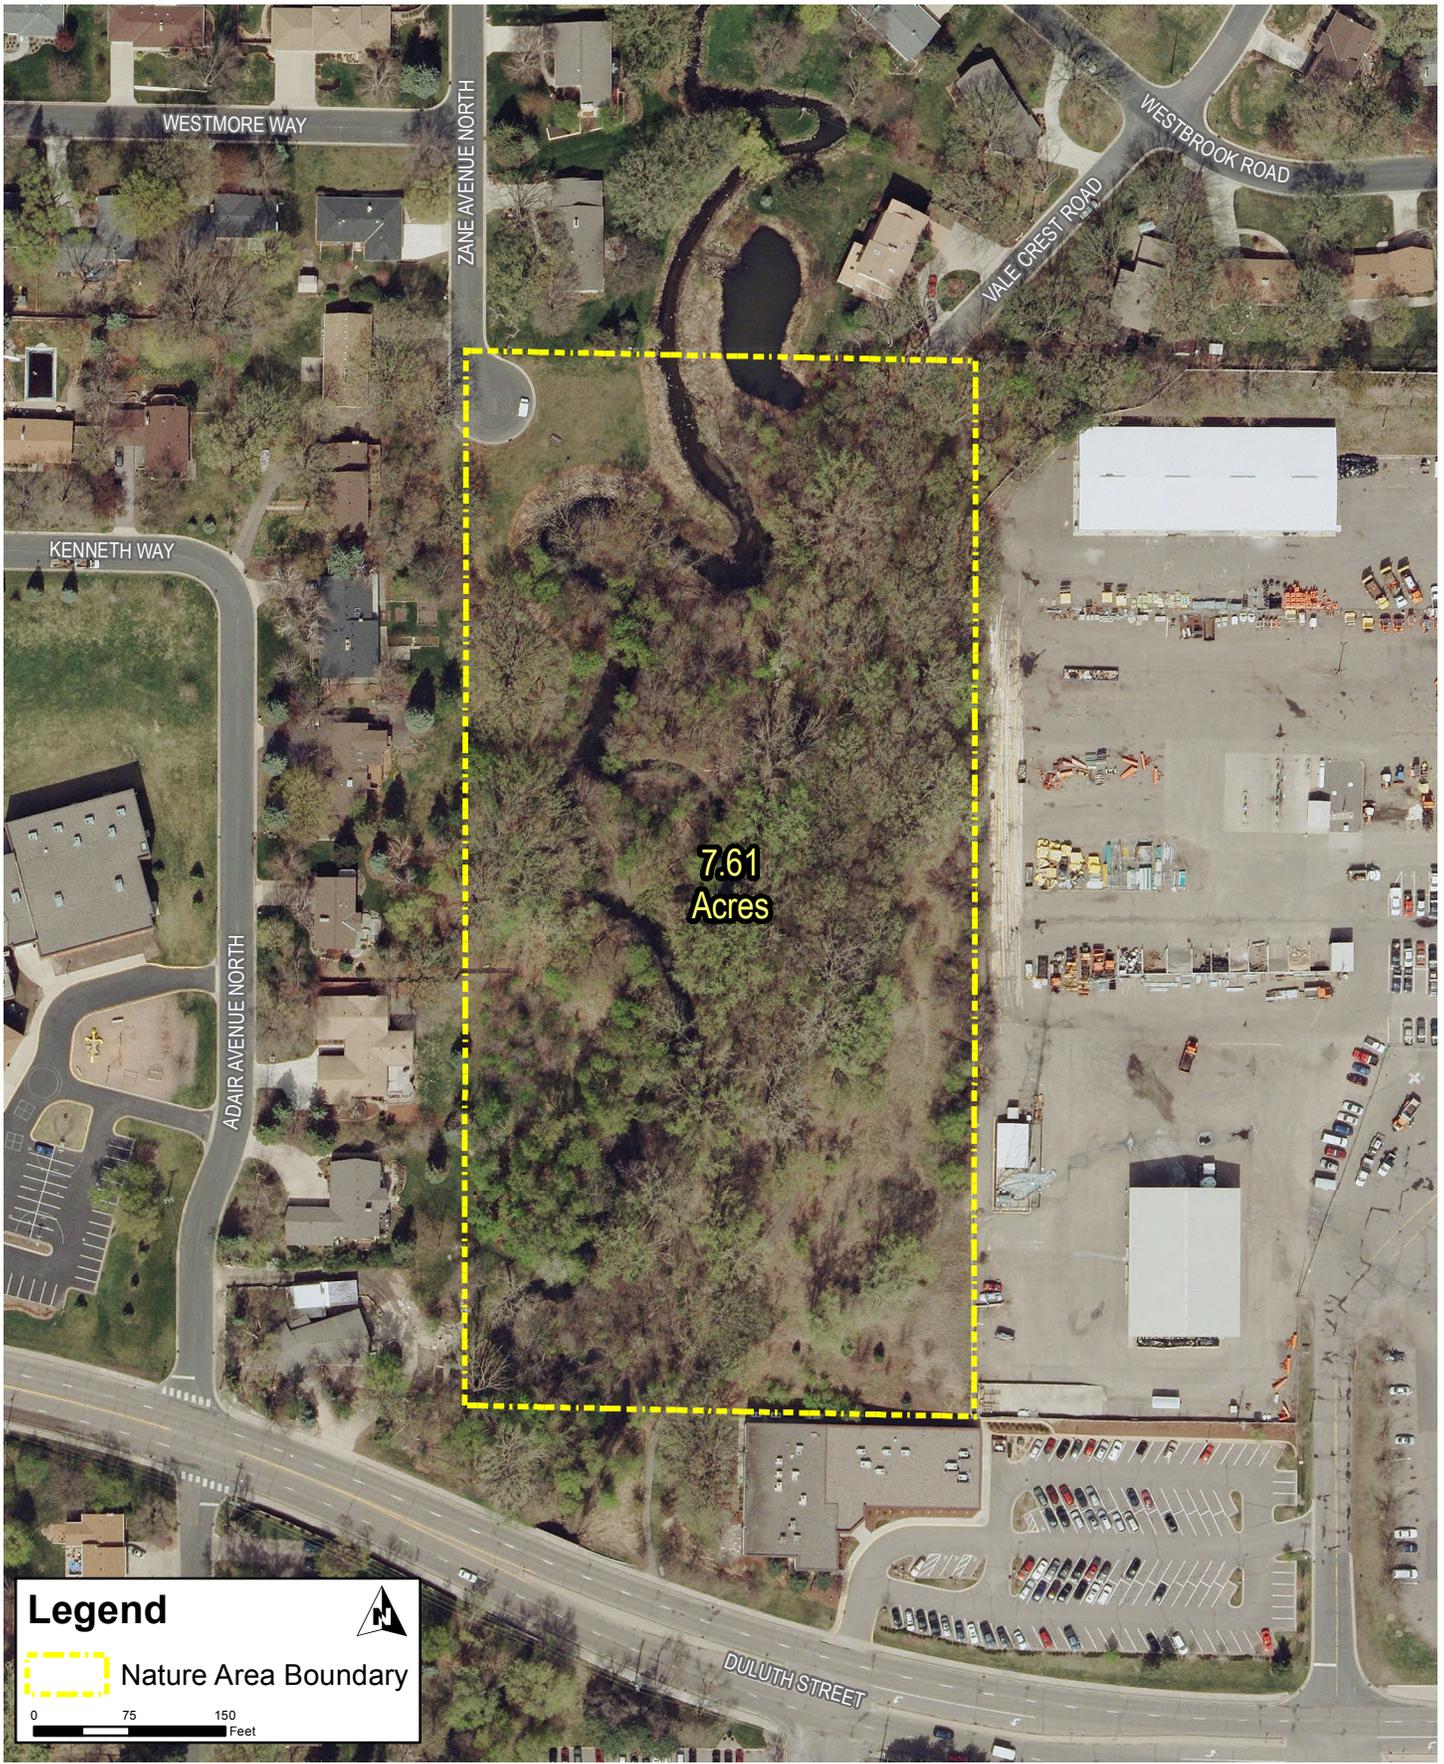
FIGURE 5.8

Land Cover	Acres	Percent
Bassett Creek	0.45	5.96%
Dry Shrub Non Native Hardwoods	1.20	15.80%
Floodplain Forest / Hardwood Swamp	3.24	42.58%
Mixed Oak Forest	2.07	27.16%
Open Water	0.04	0.58%
Park	0.16	2.09%
Paved	0.08	1.04%
Prairie	0.05	0.63%
Shrub Carr	0.32	4.16%
TOTAL ACRES	7.61	100.00%
